WHITEHALL RESERVOIR DAM

MA 00445

PHASE I INSPECTION REPORT
NATIONAL DAM INSPECTION PROGRAM

AUGUST 1978

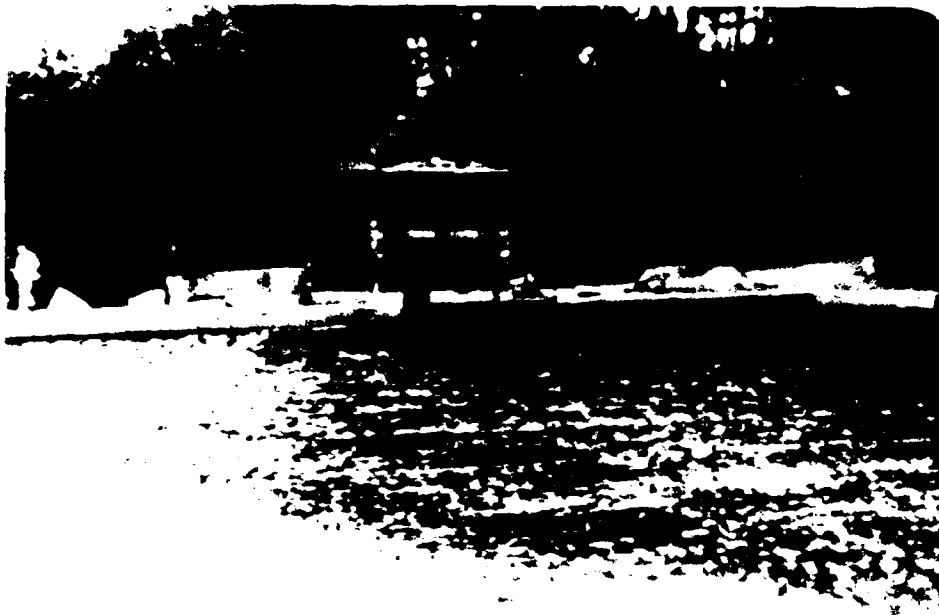
3

Upstream View of Dam

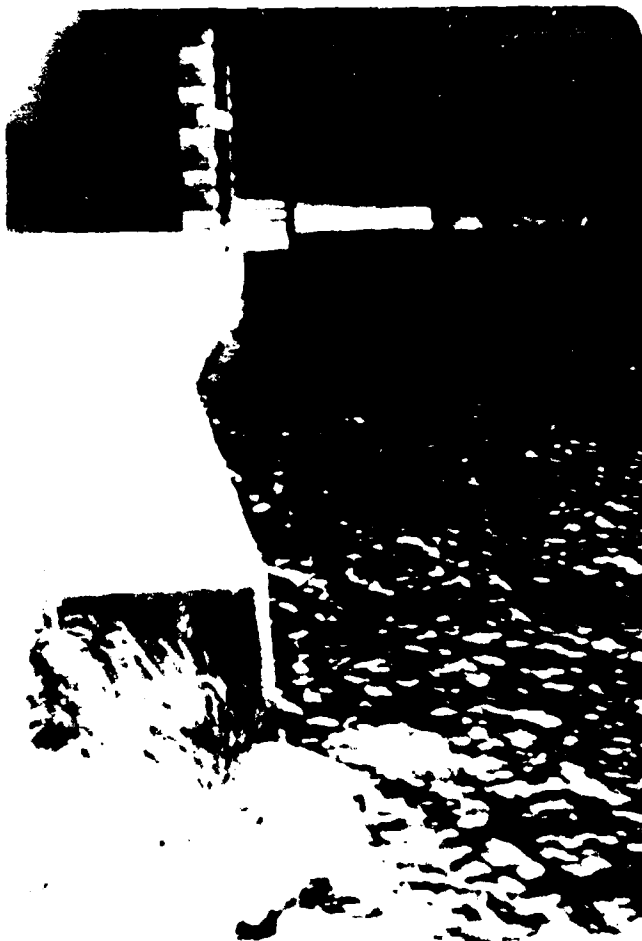
18

View along crest of Dam
from Left Bank
